**HAZARDOUS MATERIALS SURVEY  
FINAL REPORT**

**Stagg High School  
2939 Mission Road  
Stockton, CA 95204**

**Gym, Girl's Locker Room, and Boy's Locker Room Buildings  
HVAC Replacement Project**

**Entek Project #22-6190**

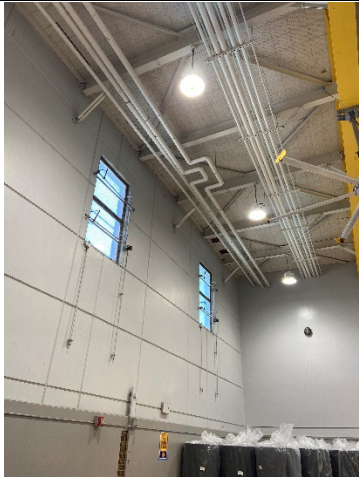
View of the overhead pipe insulation in the Wrestling Gym.

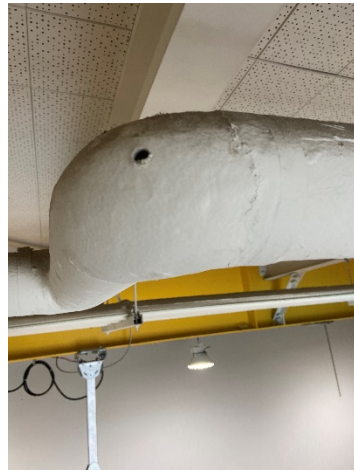
Example of the asbestos containing 6" OD Hardpack Pipe Elbow Insulation.

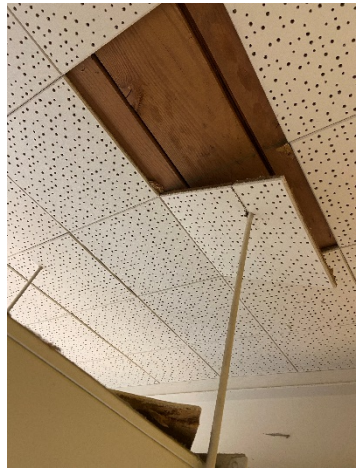
View of the nailed-on ceiling tiles.

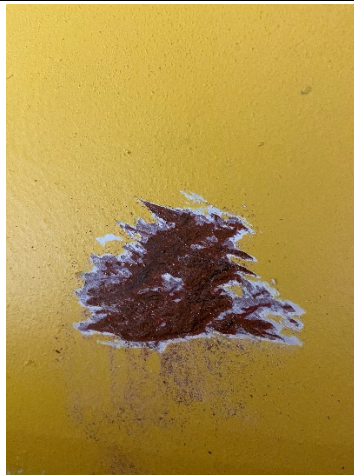
Example of the Yellow Colored Lead-Based Paint on the structural I-Beams located inside the Gym Buildings.

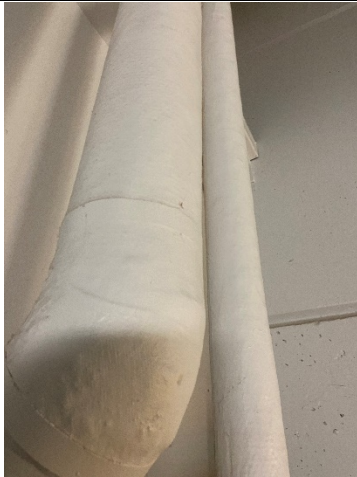
Example of the asbestos containing 8" OD Hardpack Pipe Elbow Insulation.

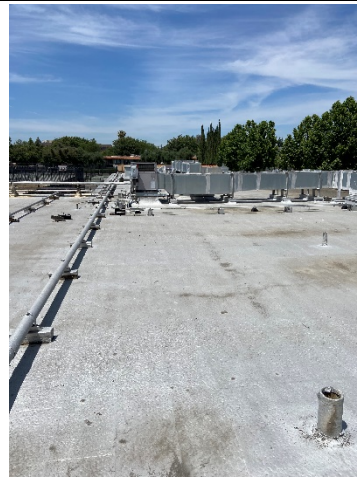
Example of the painted composition asphalt rolled roofing.

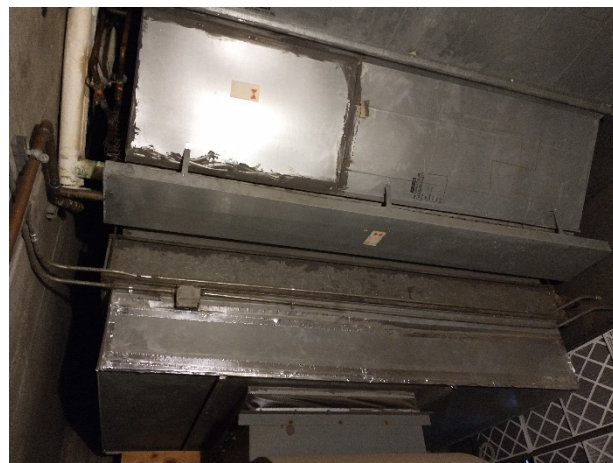
View of the HVAC Duct inside the Mechanical Room. This duct obstructed access to the pipes above.

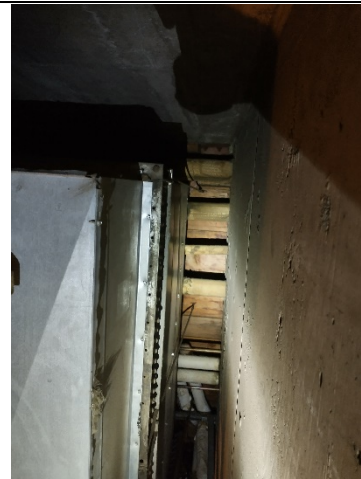
Entek observed damaged pipe insulation above a large HVAC duct inside the air handling spaces inside the Gym Building. This pipe insulation was inaccessible, but visible. Any hard pack pipe insulation found inside the air handling spaces should be assumed to contain asbestos. The exterior windows were also inaccessible, to inspect for window putty, due to being covered with metal security screens. Entek recommends these materials be treated as assumed asbestos containing materials.

Example of the 6" OD Hardpack Pipe Insulation above the HVAC Duct. The insulation around these pipes are assumed asbestos containing materials.
